CONDITION MONITORING OF ROLLING ELEMENT BEARINGS IN A GEARED ROTOR

A Thesis Submitted

MASTER OF TECHNOLOGY

DEPARTMENT OF MECHANICAL ENGINEERING
INDIAN INSTITUTE OF TECHNOLOGY KANPUR
JANUARY, 1993

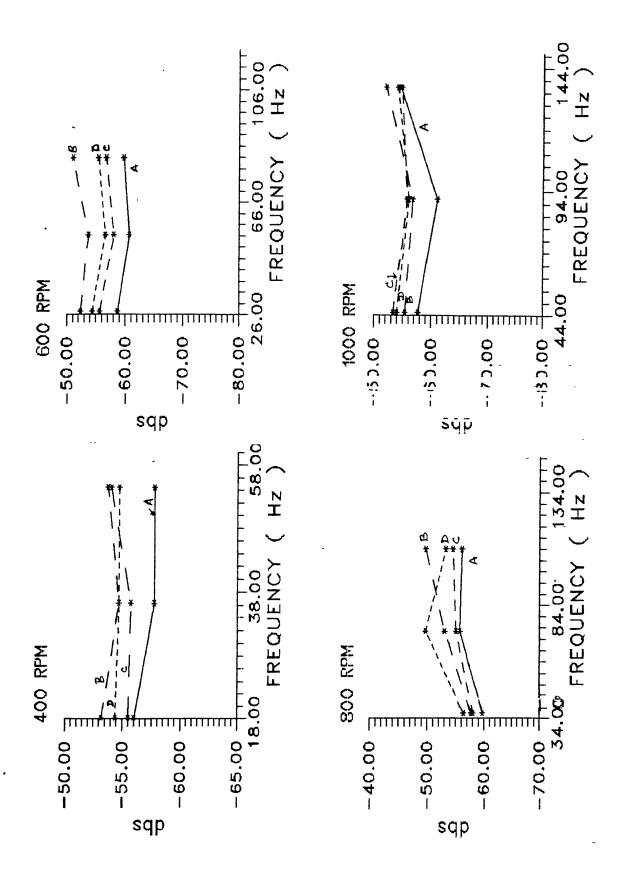
Fig 3.13 AMPLITUDE LEVELS AT IMPACT RATES (FOR OUTER RACE)

also plotted in Figs 3.13-3.14. The rise in the amplitude levels is dependent upon the gravity of fault.

For case B, where fault is very complex (cage broken , two balls free & play between races), the rise in vibration level is more as compared to case C, where only one ball is damaged. (fig 3.13). However, this rise is less in case D (excessive play between inner and outer races). For cases B & D, almost uniform rise in vibration levels can be observed at impact rates for outer race, inner race & balls; For case C, the increase in vibration level is more for impact rates related to balls than for races. This can be explained by the fact that, for cases B & D, all three components are faulty whereas for case C only one ball is damaged.

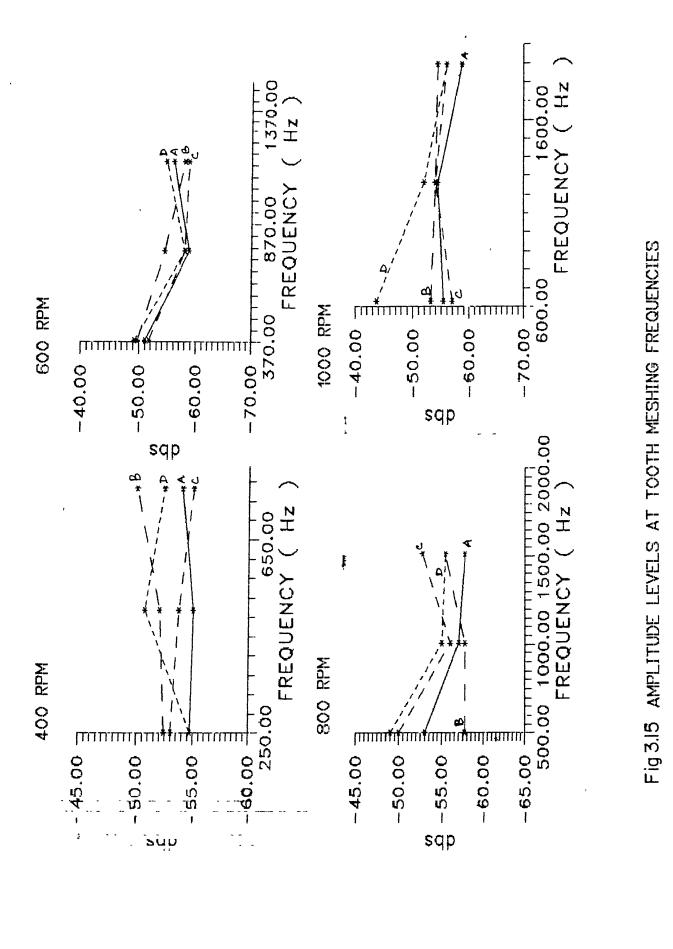
Fig 3.15 AMPLITUDE LEVELS AT TOOTH MESHING FREQUENCIES

Table 3.2 gives the amplitude levels at tooth meshing frequencies for all four cases, at all rotational speeds. For case C rise in vibration level is less then cases B & D where faults are more grave. Fig 3.15 contain plots for all the four cases for comparison. As can be seen, plot for case C lies below plots for cases B & D.
